APOLLO 9

LOW REGULATION PRESSURE IN  
ASCENT PROPULSION SYSTEM

APOLLO 9 MISSION  
LOW REGULATION PRESSURE IN ASCENT  
PROPULSION SYSTEM

PREPARED BY  
Mission Evaluation Team

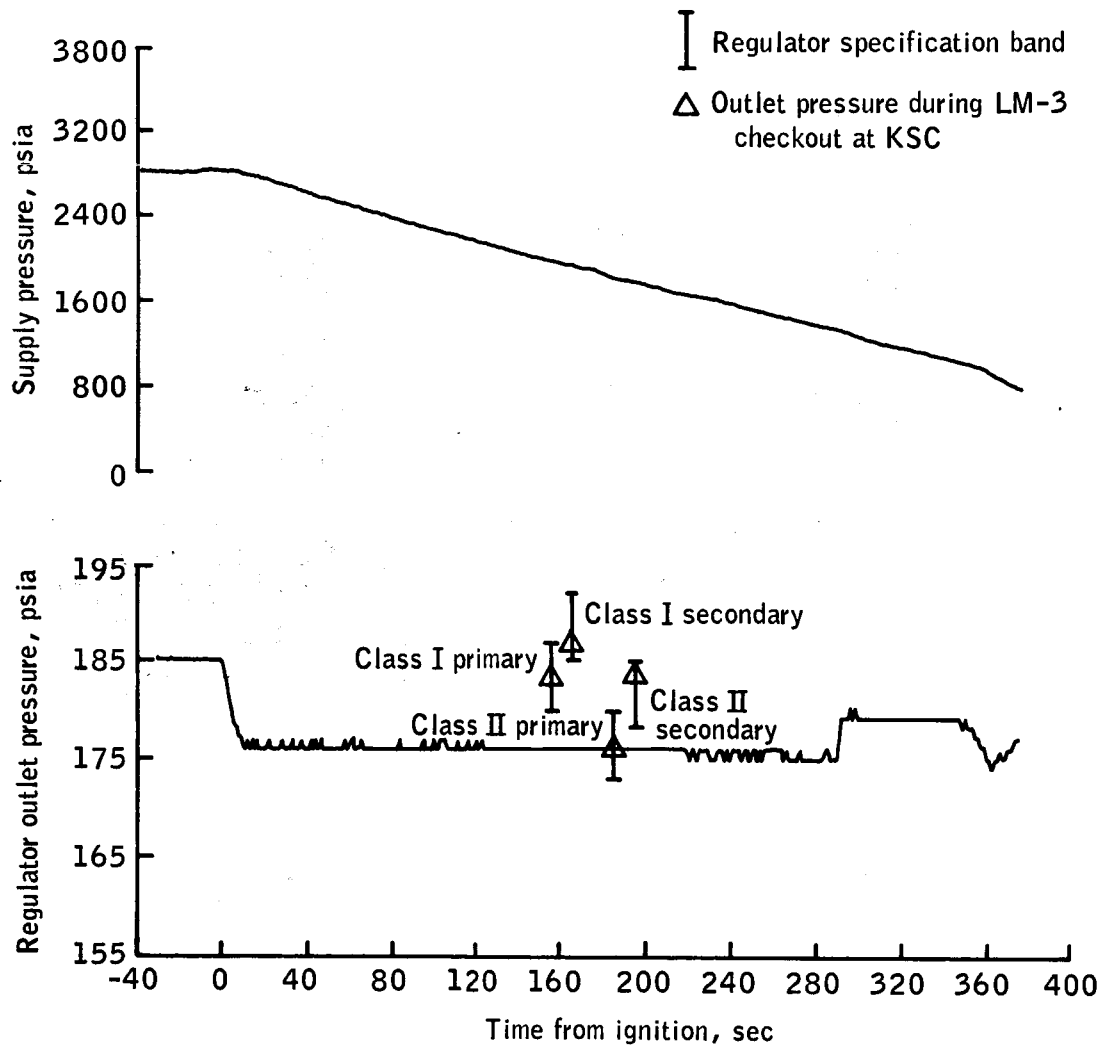
Figure 1.- Pressures during firing to depletion.

During the unmanned ascent engine firing to depletion on Apollo 9, the regulated helium pressure supplied to the propellant tanks (fig. 1) dropped from the lockup pressure of 186.5 psia to a stabilized value of 176.5 psia, 7.5 psi below the expected regulation pressure. Correspondingly, the engine propellant feed pressures and the chamber pressure stabilized at levels below intended values. At about 3 minutes into the firing, the regulated helium pressure had dropped to 175 psia. Shortly thereafter, the pressure rose rapidly to 179 psia and stabilized. During this period, the helium tank and regulator inlet pressures changed markedly in slope, showing an increase in helium flow rate. After engine shutdown, the regulated pressure locked up at the proper pressure.

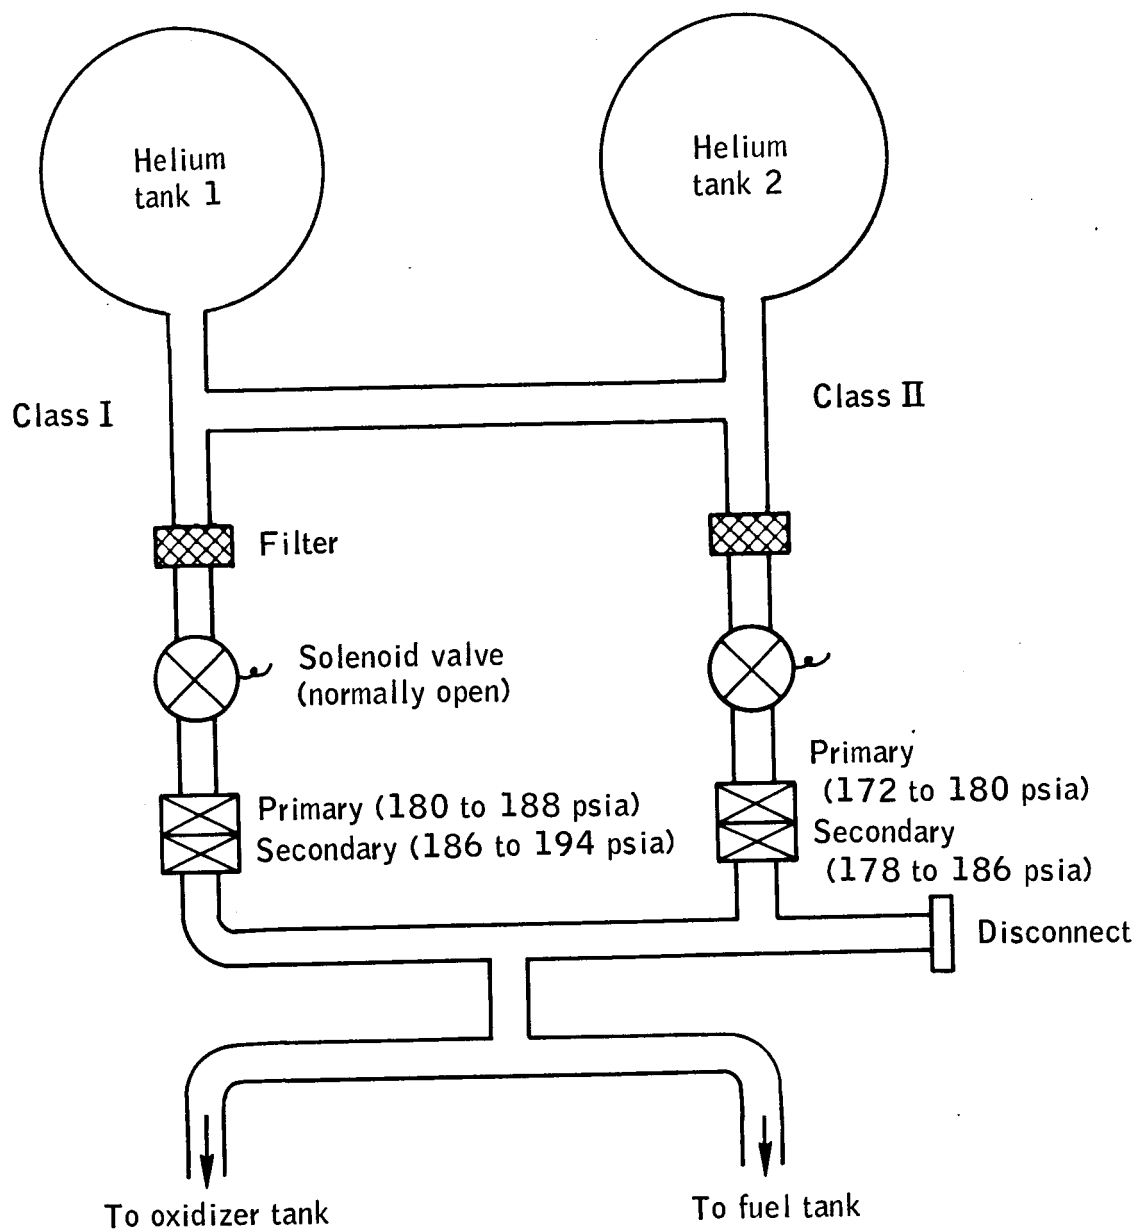
Figure 2.- Ascent propulsion pressurization system.

The ascent propellant tanks are supplied with pressurizing helium by two redundant parallel helium regulator legs, each consisting of two regulators in series (fig. 2). The two parallel legs protect against a failed-closed regulator, and the two series regulators in each leg protect against both a failed-open regulator and one that will not lock up. A filter is installed upstream of each regulator leg to protect the leg from contamination. In addition, an integral filter is included in the inlet of the upstream regulator in each leg. During normal operation, one regulator leg (class I) will supply most of the flow, and the outlet pressure will be regulated by the primary unit in that leg.

The low regulation pressure (176.5 psia) for the first 290 seconds of the firing could have been caused by a downshift in the regulation range of the primary regulator in the class I leg or by a flow restriction in the regulator in the class I leg, causing the class II leg to supply most of the flow and its primary regulator to control outlet pressure. To determine whether the class I regulator leg attempted to flow during the engine start, a test was conducted assuming the class I leg was inoperative. The system was pressurized by the class I regulators to their lockup level. Then, the solenoid valve in the class I leg was closed, followed by an engine firing, thereby forcing control through the class II leg. This test verified that the Apollo 9 system had little or no flow until the pressures dropped to the primary regulator level of the class II leg.

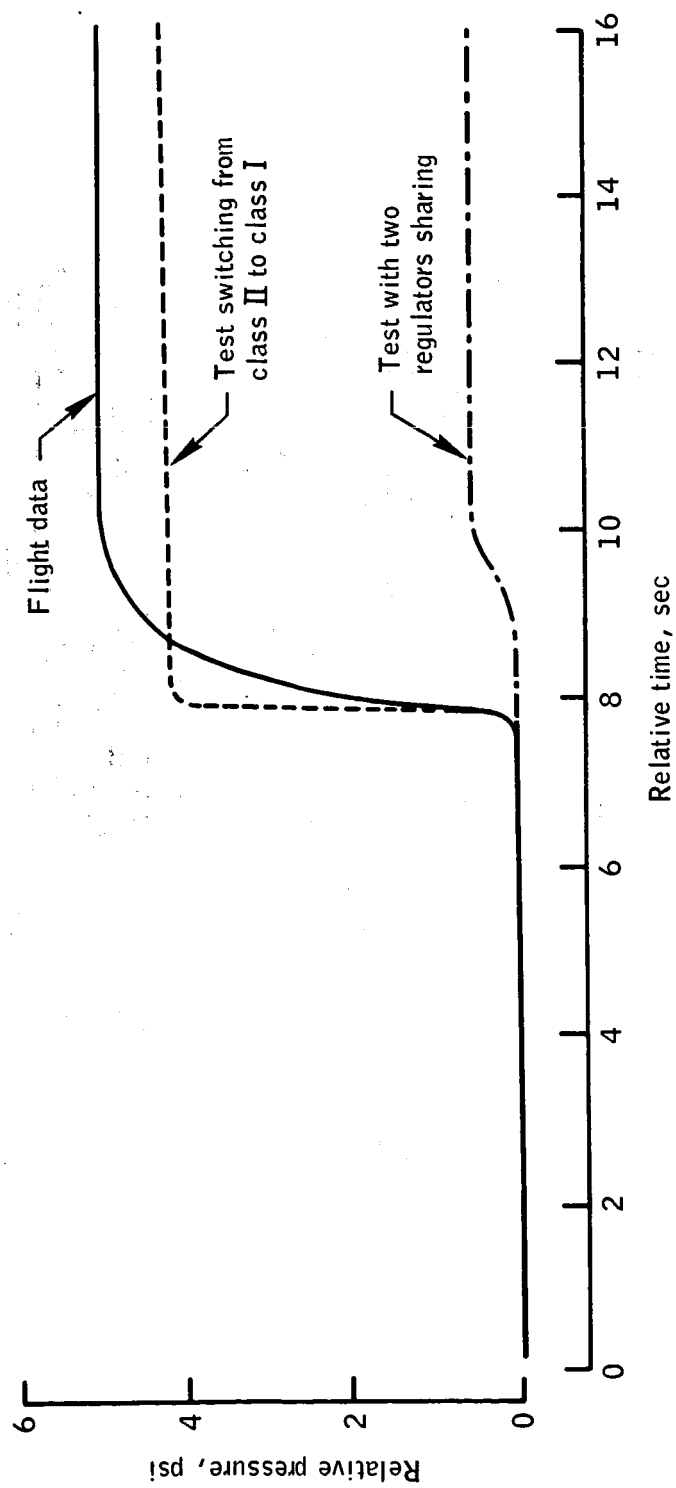
Figure 3.- Changes in regulator outlet pressures.

At 290 seconds into the firing, the pressures in the regulator manifold increased 4 psi in 1-1/2 seconds. This increase was also experienced at the engine interface; however, the pressure rise time was 20 seconds, corresponding to the time to increase the ullage pressure. Three possibilities could have caused the step increase.

3. The step increase was duplicated in tests by allowing the class I regulator leg to start controlling, shutting off flow in the class II leg (fig. 3). This was accomplished by setting regulation bands 4 psi apart, with the class I solenoid valve closed at the start of the firing. Opening of the solenoid valve allowed the class I regulator to start flowing and duplicated pressure increases observed during Apollo 9.

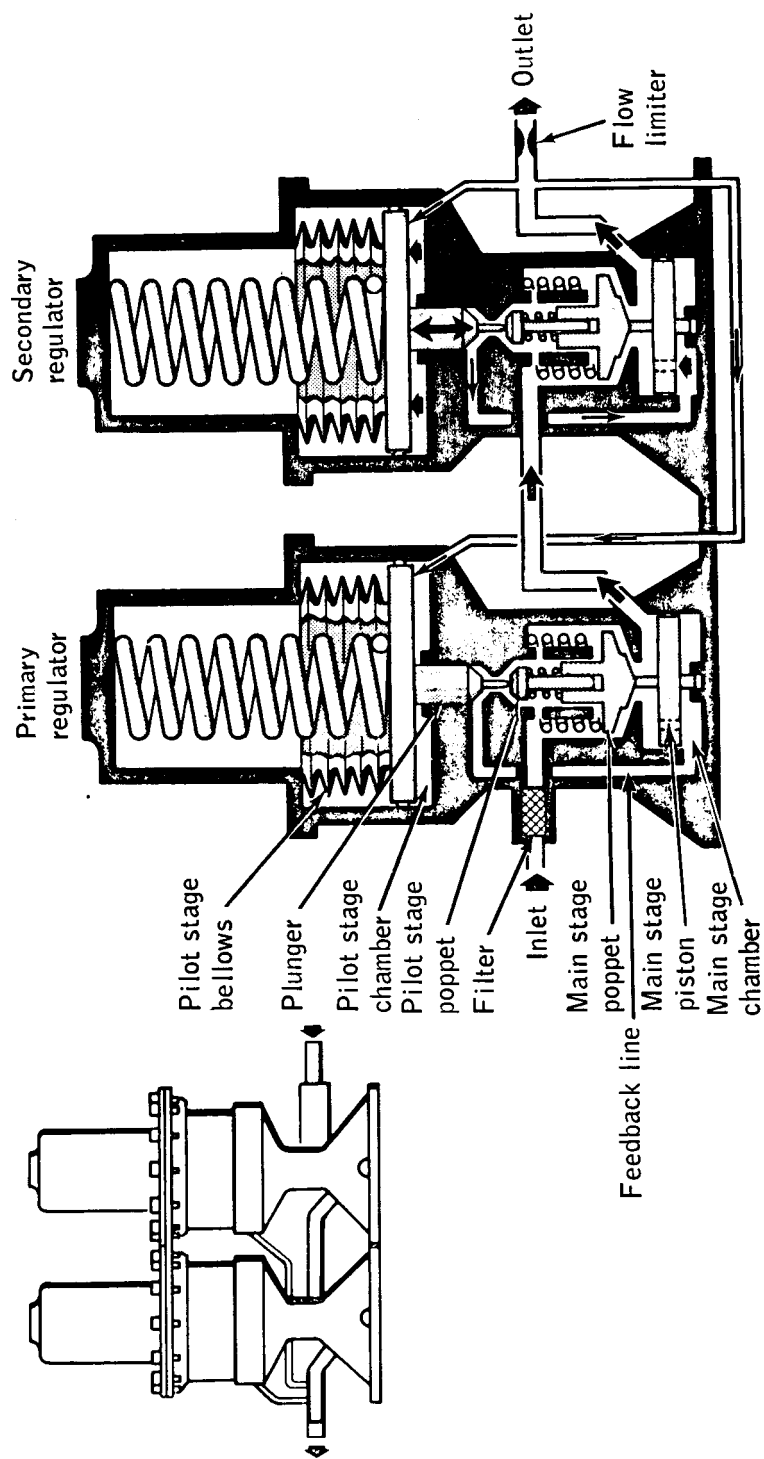
Figure 4.- Helium regulator.

One of the following failure modes appears most likely, based on an analysis of assumed conditions. (Figure 4 shows a cutaway view of the regulator.)

1. A regulation band shift caused by contamination, creating a restriction to flow in the feedback line from pilot poppet to main stage piston.

2. Contamination preventing movement of the main poppet sleeve and guide, piston, or guide and body in response to outlet pressure demand.

3. Galling of the main piston in the bearing area, causing unstable regulation, including downshift and subsequent recovery.

For subsequent lunar modules on which replacement of components is necessary, the tubing on both sides of the defective component will be cut. The tube bore will be visually inspected and wiped out with a swab to remove any chips formed by the tubing cutter. The line ends will then be deburred using a tool incorporating a plastic contaminant barrier which slides into the tube ahead of the tool. This barrier wipes the tube bore during removal. The deburring tool also includes a vacuum attachment which picks up chips formed during the deburring operation. Previously, the tubing was purged during the deburring operation to sweep

out any contaminants formed. In the future, no purge or flow of any kind will be used. This procedure was successfully used during a solenoid valve replacement on LM-7.
